Conceptual Review Submission

to the District of Columbia Historic Preservation Review Board

1922 3rd Street, NW • Washington, DC • 20001

Description of Project: Addition and Exterior Alterations

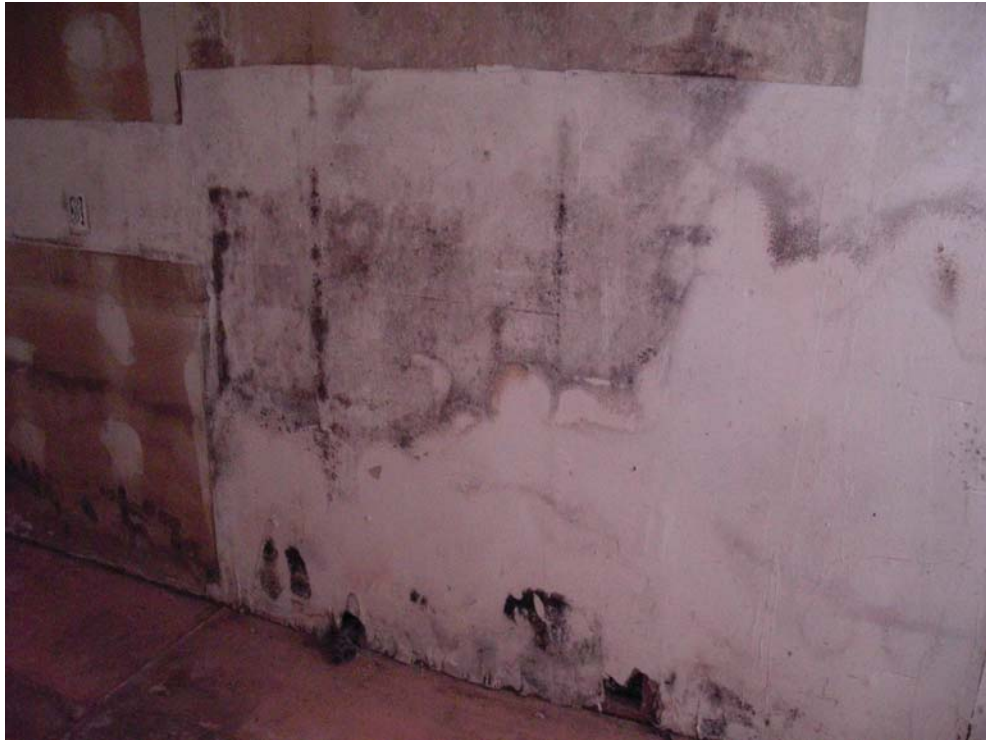
View of black mold growing in the main structure

2. The slate roof is in need of much repair if not total replacement.
3. The chronic penetration issues have contributed to a major black mold issue throughout most of the house. Toxic conditions likely exist.

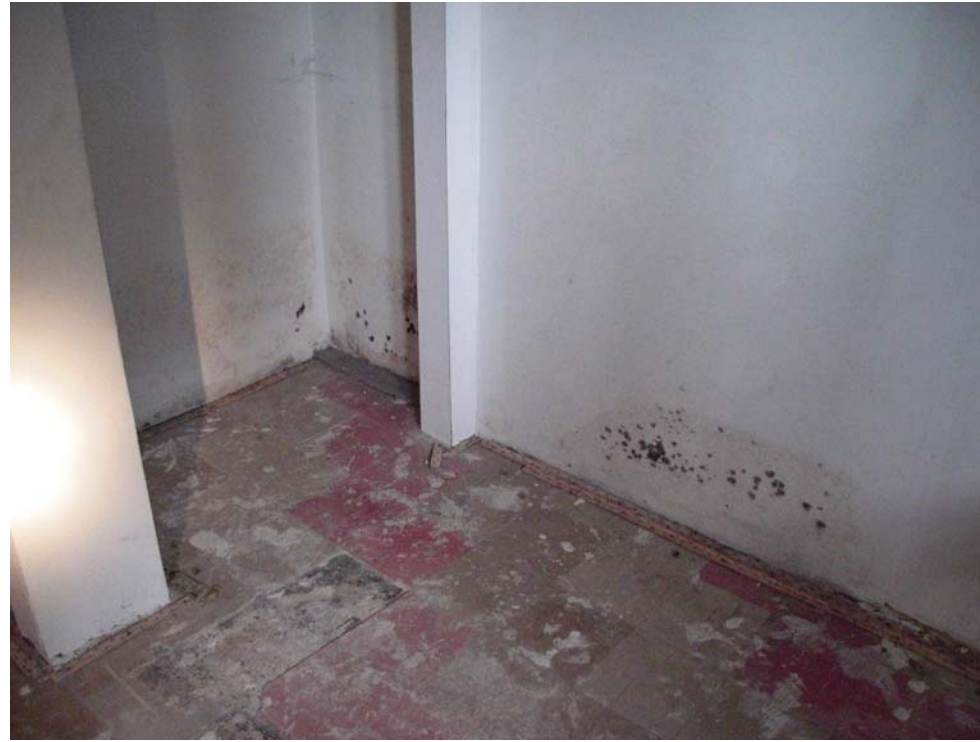
View of asbestos tile in the main structure

4. Open sewer lines are likely contributing to methane sewer gas buildup within the house.
5. Asbestos floor tiles, lead paint are also hazardous materials present within the house.

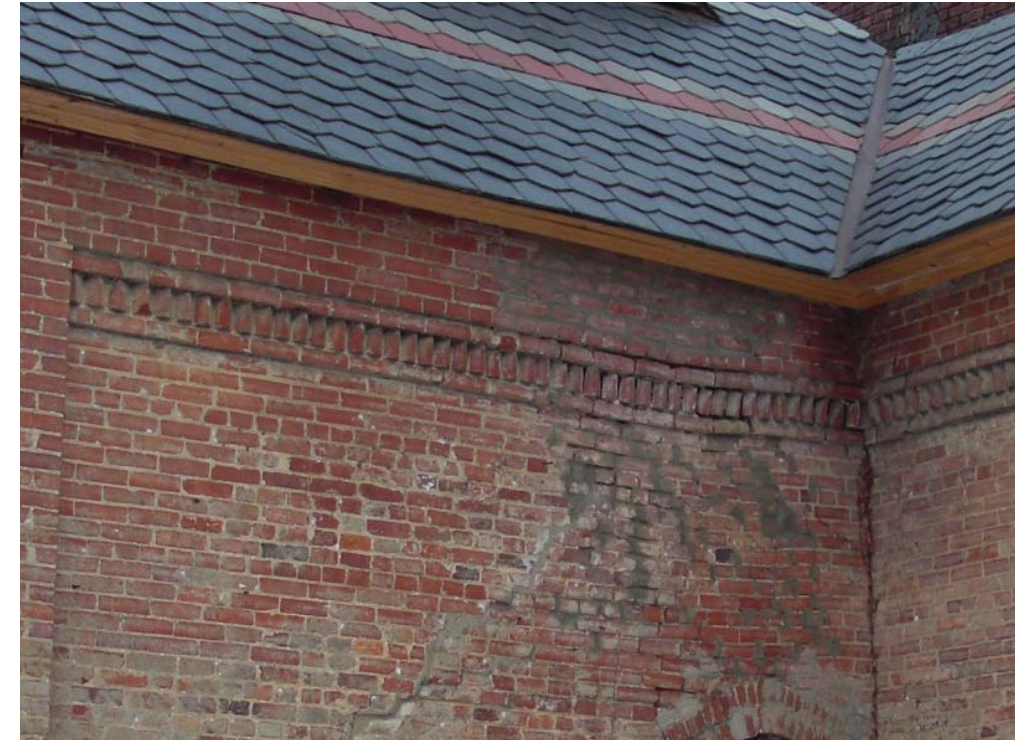
View of masonry failure in the carriage house

1. There are numerous structural concerns including:
 - a. Foundation failure at the rear chimney of the main house.
 - b. Foundation failure at the front wall of the carriage house.

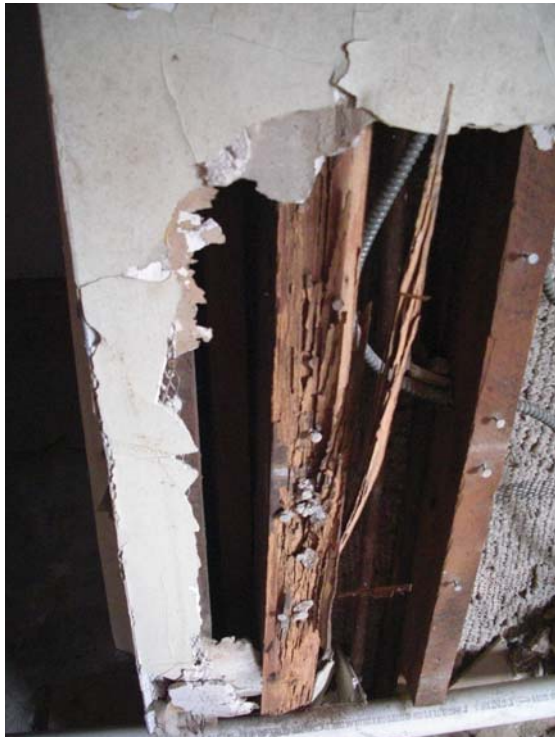
View of termite damage in the main structure

- c. Loss of brick mortar at the main house foundation walls.
 - d. Extensive damage from rot and termite infestation in more than a few areas.
 - e. Several areas where framing of structural components such as floor joists have been cut/removed to accommodate house plumbing without re-support.

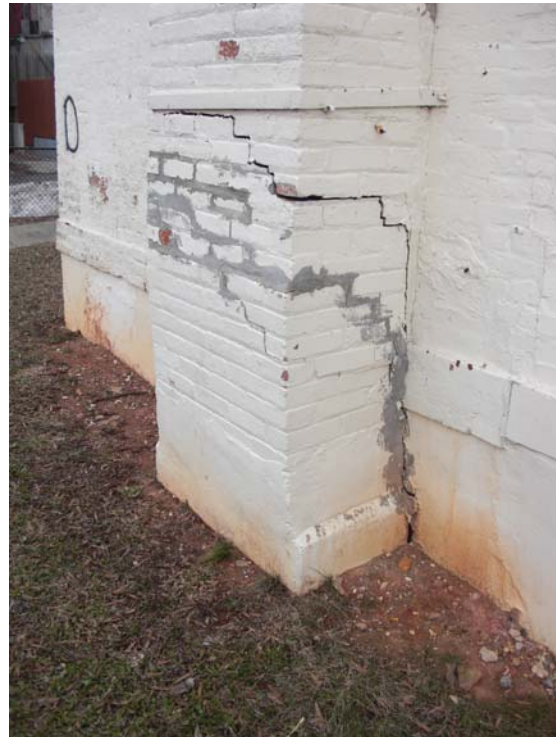
View of foundation failure in the main structure

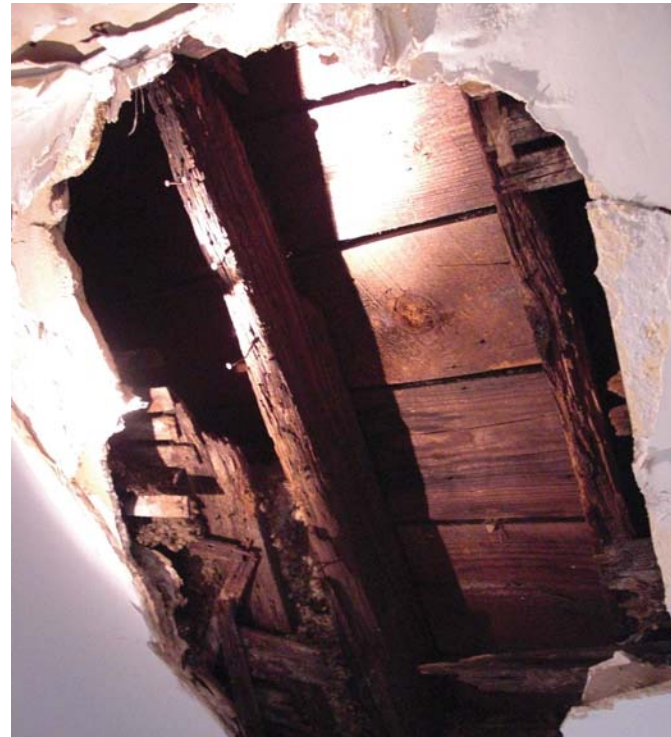
View of structural roofing failure in the main structure

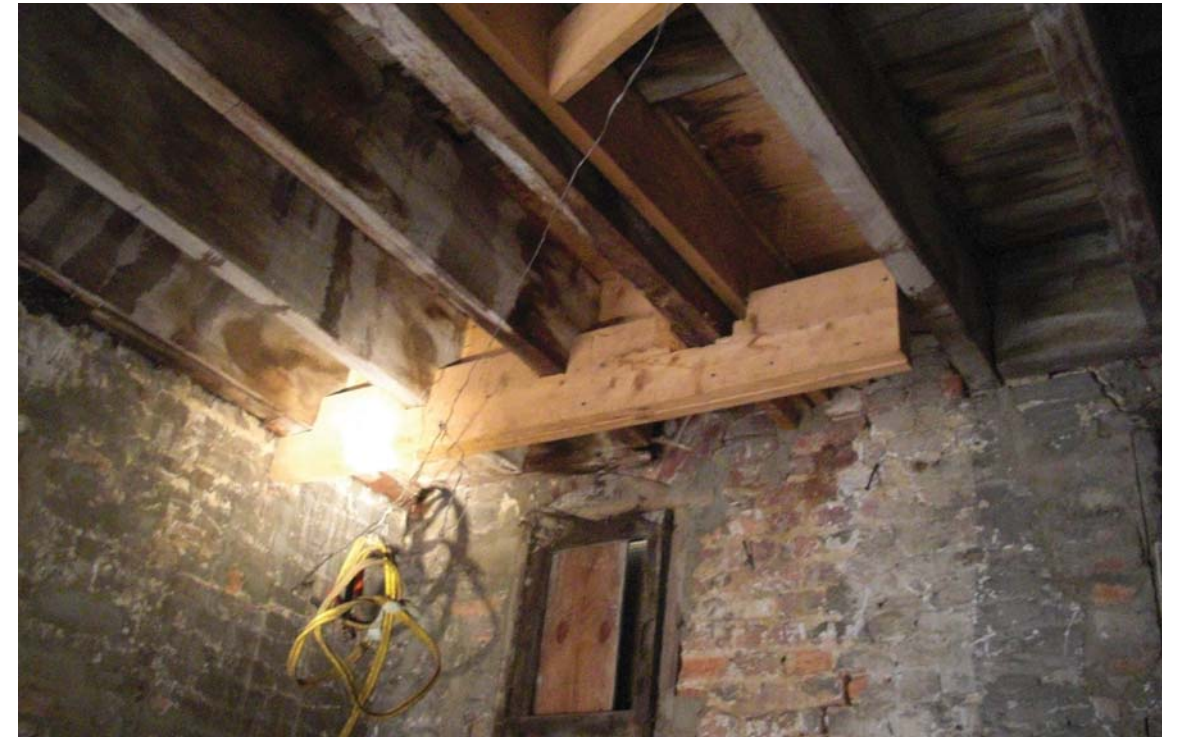
View of inadequate structural members in the carriage house

6. The upper floor framing of the carriage house is highly hazardous.
